Installing an automatic overhead crane in complex conditions

Installation issues of an automatic overhead crane on a partially renovated industrial building of a cement plant are presented. Due to particular soil conditions as well as structural inhomogeneities dictated by production requirements, mechanical, structural and also geotechnical aspects had to be carefully considered in a close cooperation among different engineering competences.

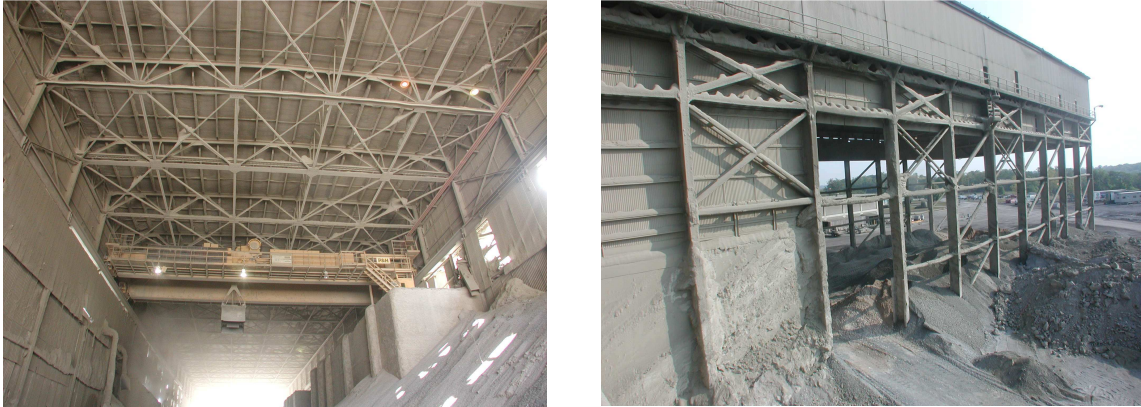
Figure 1: existing building

Most of the existing hall consists of an open steel frame, with 33' (10 m) high steel columns stemming from longitudinal concrete retaining walls, 48' high (14.4 m) (Figure 1, left). The balance of the hall is supported by longer steel columns, extending down to grade (Figure 1, right). Transverse dimension is

about 84' (25.5 m); main portal frames are provided at 21' (6.40 m), while the overall hall length exceeded 600' (180 m). A crane was working in this storage area, running over 21' long rail beams. This department was originally used to store limestone.

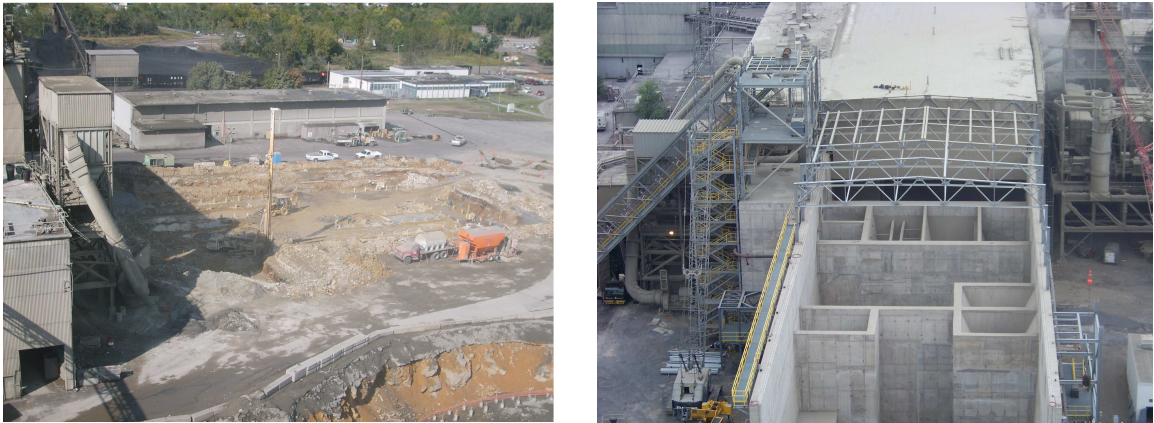
Figure 2: new building during various construction stages: piling (left), roof erection (right)

foundation (Figure 2, left) for the new building was deemed by local soil engineers to be the most appropriate solution.

Therefore at the interface between the existing and the new part (Figure 2, right), very different structures existed, in terms of both lateral and vertical stiffness.
